## NIAGARA FALLS AIR FORCE RESERVE FACILITY, NEW YORK

DECEMBER 1983

# INSTALLATION RESTORATION PROGRAM PHASE I - RECORDS SEARCH NIAGARA FALLS AIR FORCE RESERVE FACILITY NEW YORK

ENGINEERING-SCIENCE 57 Executive Park South, Suite 590 Atlanta, Georgia 30329 #36306

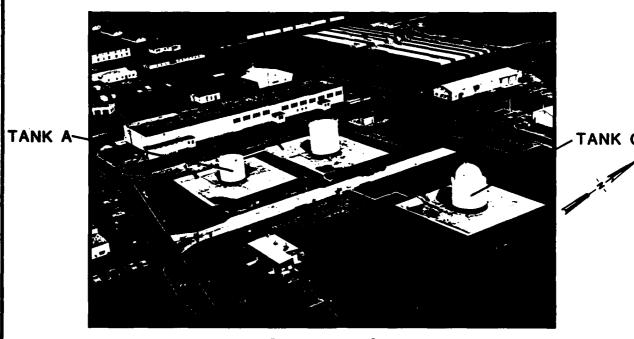
**POL Storage Area**

The POL storage area leaks occurred when the underground inlet pipe to JP-4 storage tank A developed a leak in 1979 and when the inlet and outlet pipes to tank C developed leaks in 1982. Both leaks were detected when fuel began to surface in the area of the underground pipes and appeared in storm water drainage. In the case of Tank A, the fuel surfaced near the fuel pump house and inside the diked area. In case of Tank C the fuel appeared between the diked area and the tank truck loading facilities and in the oil water separator that drains the diked area. In both cases the fuel lines were pressure tested and found to lose pressure at a rapid rate. Subsequent removal of the pipe found the black iron pipes badly corroded with numerous small holes on the bottom side. This indicates the leaks developed over an extended period of

time and potentially could have released large quantities of fuel. Accurate estimates of these losses are not possible because previous fuel inventory procedures did not take into account the effect of temperature on tank volume, but it is reasonable to assume that the leaks amounted to several thousand gallons.
